# RESERVE STUDY

## Wynfield

### Property Owners Association, Inc.

Huntersville, North Carolina  
April 20, 2020

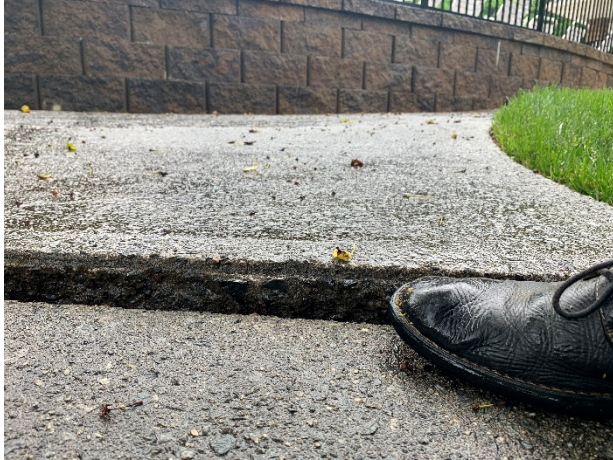
**Trip hazards evident at the sidewalks – we recommend the Association fund these repairs through the operating budget**

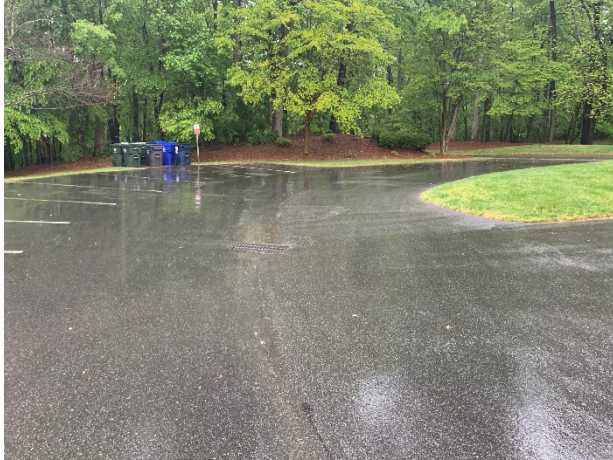
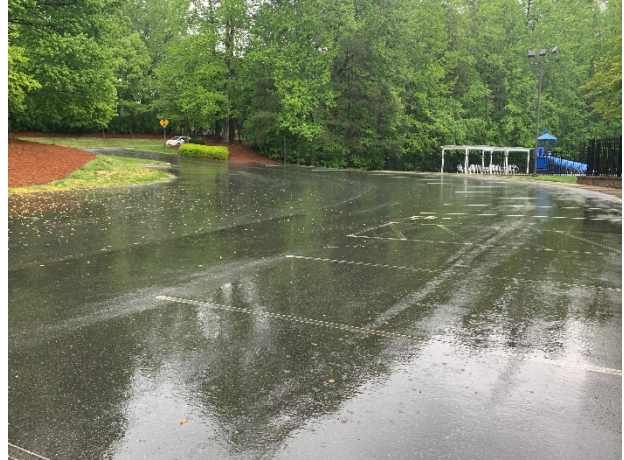
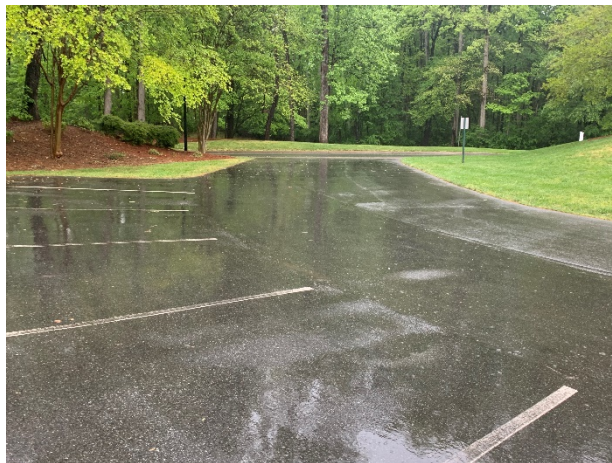
**History:** The association completed a total replacement of the parking lot in 2015

**Condition:** Good to fair overall

**Parking lot overview**

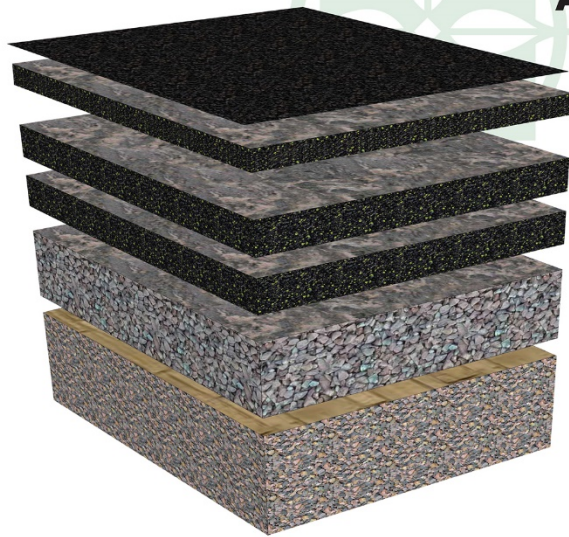
## ASPHALT DIAGRAM

**Component Detail Notes:** The initial installation of asphalt uses at least two lifts, or two separate applications of asphalt, over the base course. The first lift is the binder course. The second lift is the wearing course. The wearing course comprises a finer aggregate for a smoother more watertight finish. The following diagram depicts the typical components although it may not reflect the actual configuration at Wynfield:

**Sealcoat or Wearing Surface**

**Original Pavement** Inspected and milled until sound pavement is found, usually comprised of two layers

The manner of repaving is either a mill and overlay or total replacement. A mill and overlay is a method of repaving where cracked, worn and failed pavement is mechanically removed or milled until sound pavement is found. A new layer of asphalt is overlaid atop the remaining base course of pavement. Total replacement includes the removal of all existing asphalt down to the base course of aggregate and native soil followed by the application of two or more new lifts of asphalt. We recommend mill and overlay on asphalt pavement that exhibits normal deterioration and wear. We recommend total replacement of asphalt pavement that exhibits severe deterioration, inadequate drainage, pavement that has been overlaid multiple times in the past or where the configuration makes overlayment not possible. Based on the apparent visual condition and configuration of the asphalt pavement, we recommend the mill and overlay method of repaving at Wynfield.

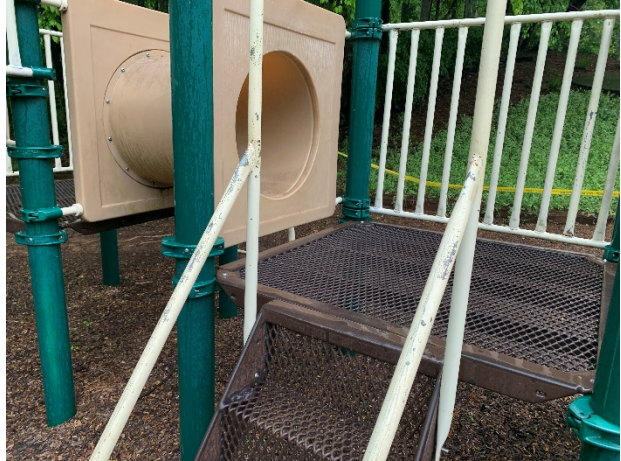
**Condition:** Fair overall with finish deterioration evident. The Association informs us of plans to refinish and move the playground through means other than reserves overall

**Finish deterioration evident**

**Component Detail Notes:** Safety is the major purpose for maintaining playground equipment. We recommend an annual inspection of the playground equipment to identify and repair as normal maintenance loose connections and fasteners or damaged elements. We suggest the Association learn more about the specific requirements of playground equipment at [PlaygroundSafety.org](http://PlaygroundSafety.org). We recommend the use of a specialist for the design or replacement of the playground equipment environment.

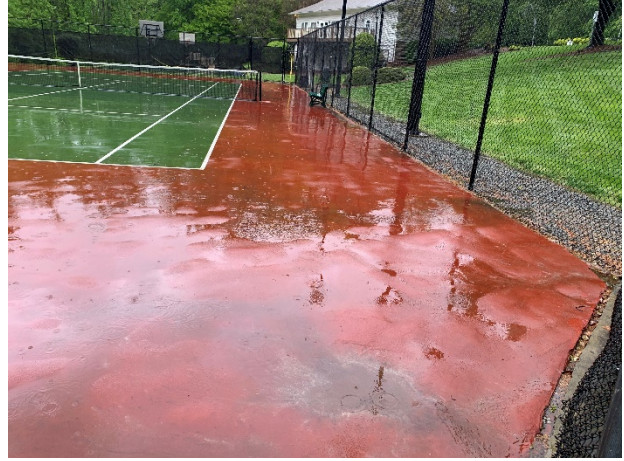
**Condition:** Poor overall with severe cracks and settlement evident throughout

**Settlement evident**

**Priority/Criticality:** Not recommended to defer

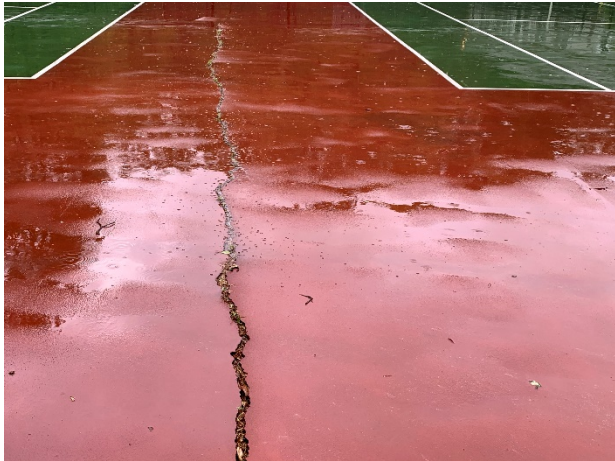
**Severe cracks evident**

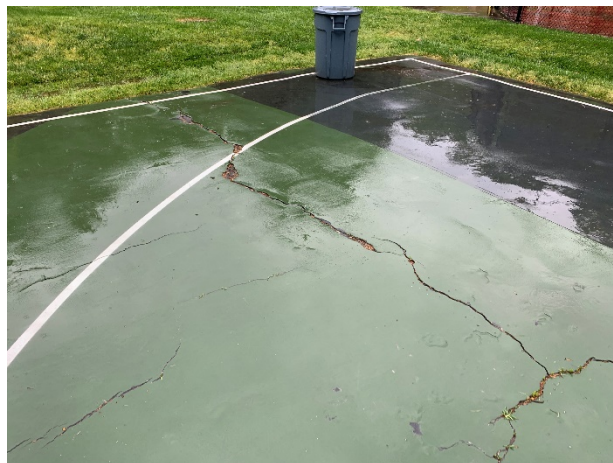
**Cracks evident**

**Condition:** Poor overall with severe cracks and settlement evident throughout

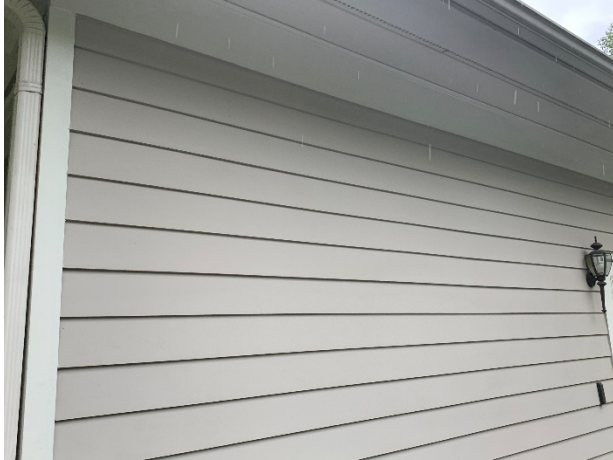
**Condition:** Good to fair overall

**Composite hardboard siding at the clubhouse**

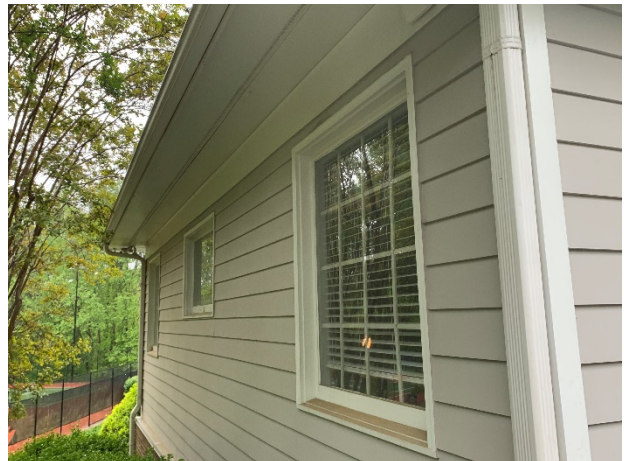
**Paint finishes and sealants at the clubhouse**

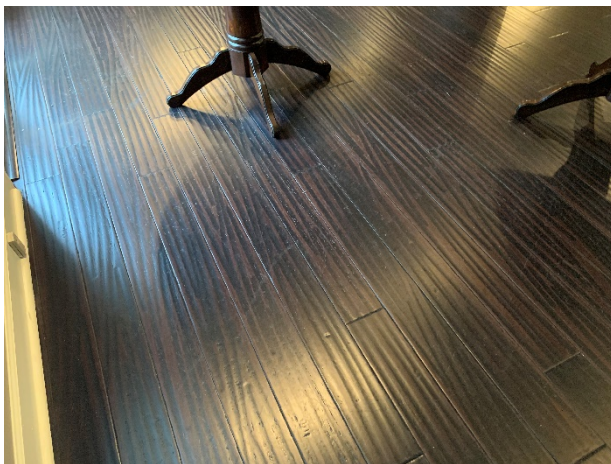
**Condition:** Good to fair overall with scuffs evident

**Wood flooring – scuffs evident**

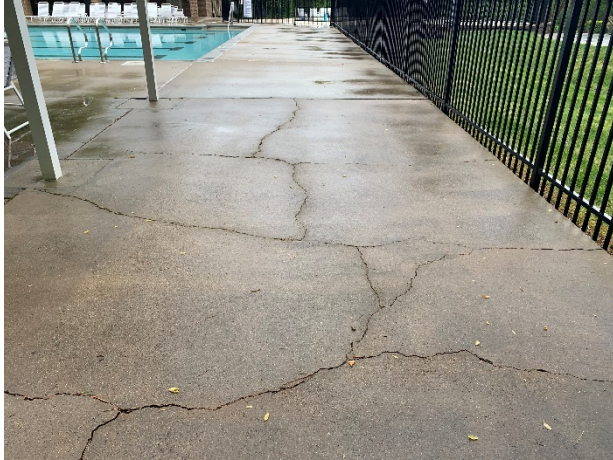
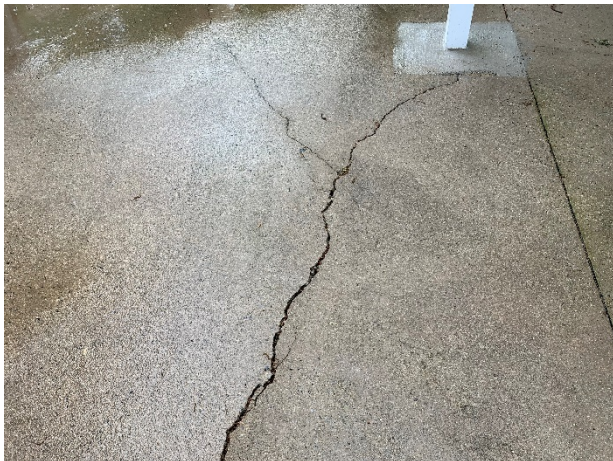
**Condition:** Fair overall with cracks evident throughout

**Cracks evident**

**Useful Life:** The useful life of a concrete pool deck is up to 60 years or more with timely repairs. We recommend the Association conduct inspections, partial replacements and repairs to the deck every 8- to 12-years in conjunction with coating replacements

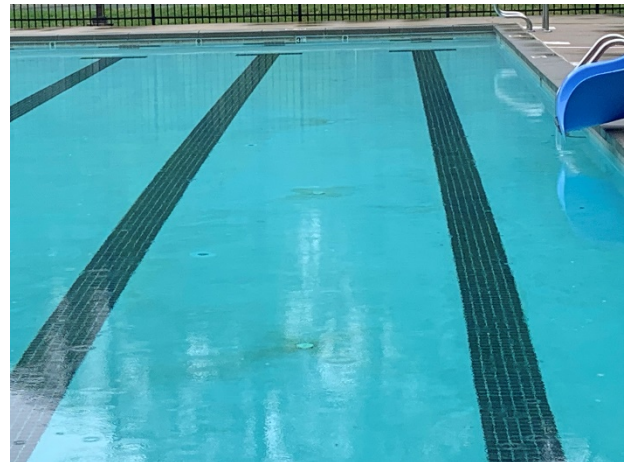
**Condition:** Good to fair overall with staining at the drains evident

**Stains around the drains evident**
